GARDEN HOME

Erosion Mitigation Plan

Report

Project Number: KH-1025

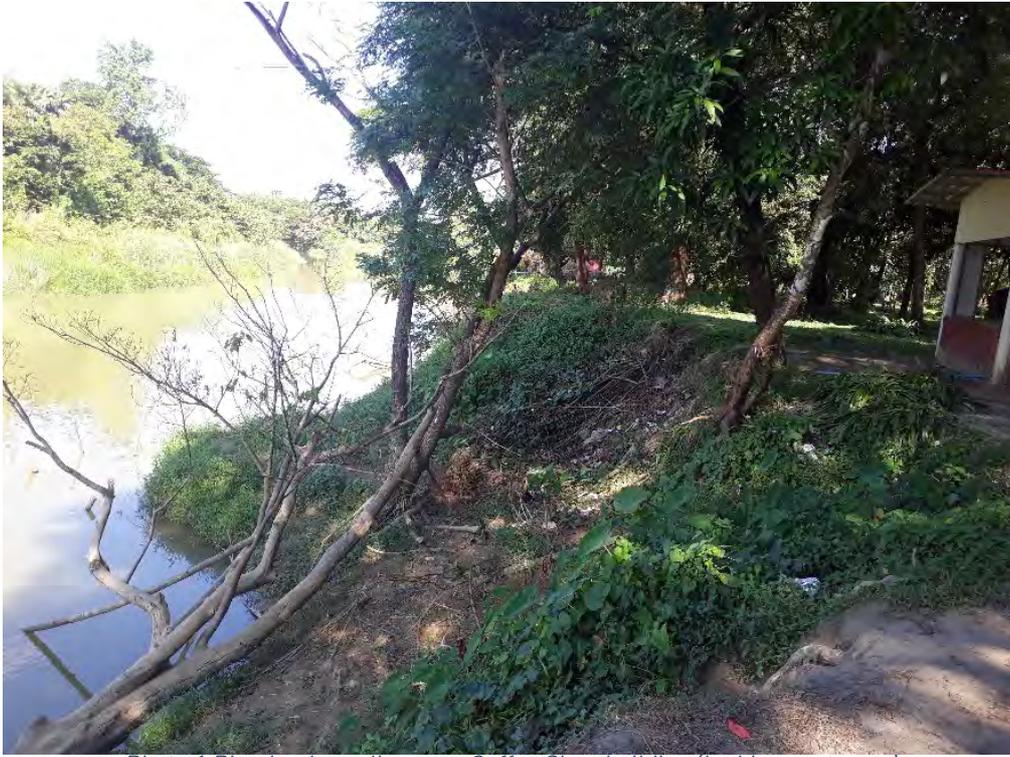
EMI Cambodia identified the approximately 80 feet of riverbank directly behind of the Coffee Shop as a critical area because erosion is occurring from both the river flow and poor drainage and it is the only section of riverbank where a building is at risk of toppling (see Photo 1). The Coffee Shop building is a simple concrete slab and roof structure with no electricity or plumbing. It has two sinks where the water poured into the sinks drains directly outside the building, causing more erosion. The rest of the eroding riverbank is a steep edge from the top of the bank to the water surface indicating that the erosion is mostly only occurring from the flow of the river, as seen in Photo 2.

Photo 1 Riverbank eroding near Coffee Shop building (looking upstream)

As shown in the attached drawing set (C0-C4), the mitigation plan is to cut back the riverbank and build a benched slope using 6-9" diameter rocks. The rocks will be underlain with a compacted gravel and/or sand material, which will be underlain with a non-woven geotextile fabric. The toe of the slope will consist of 3" diameter bakau piles and a hexagonal chain link fence.

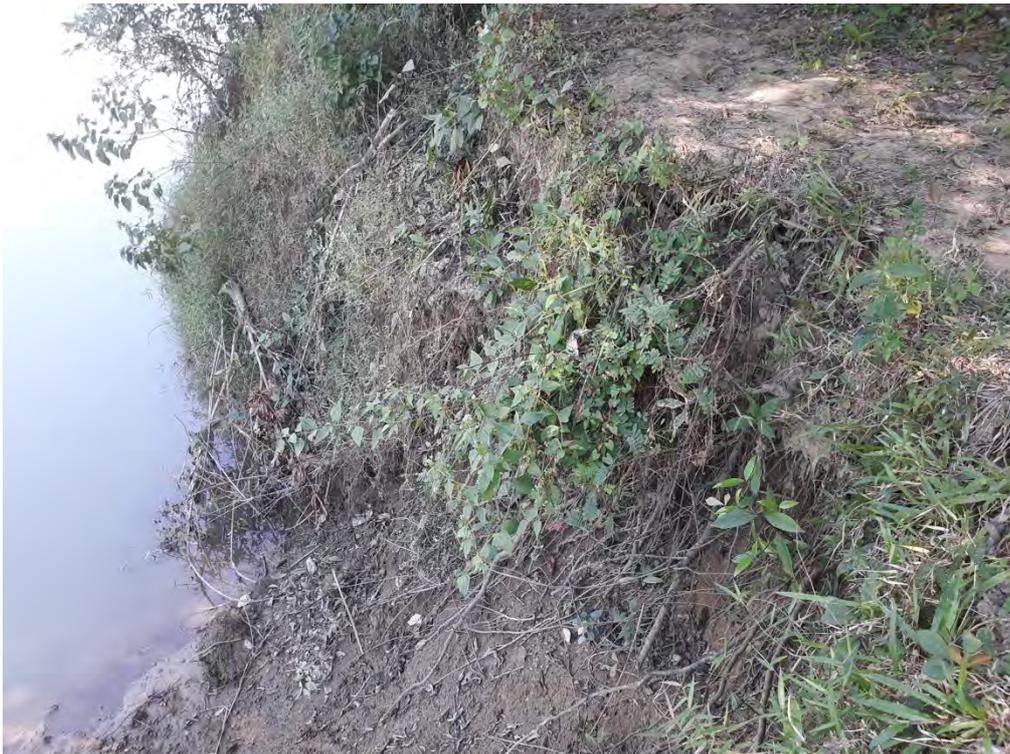
Photo 2 Riverbank eroding – near vertical drop from top of bank to water

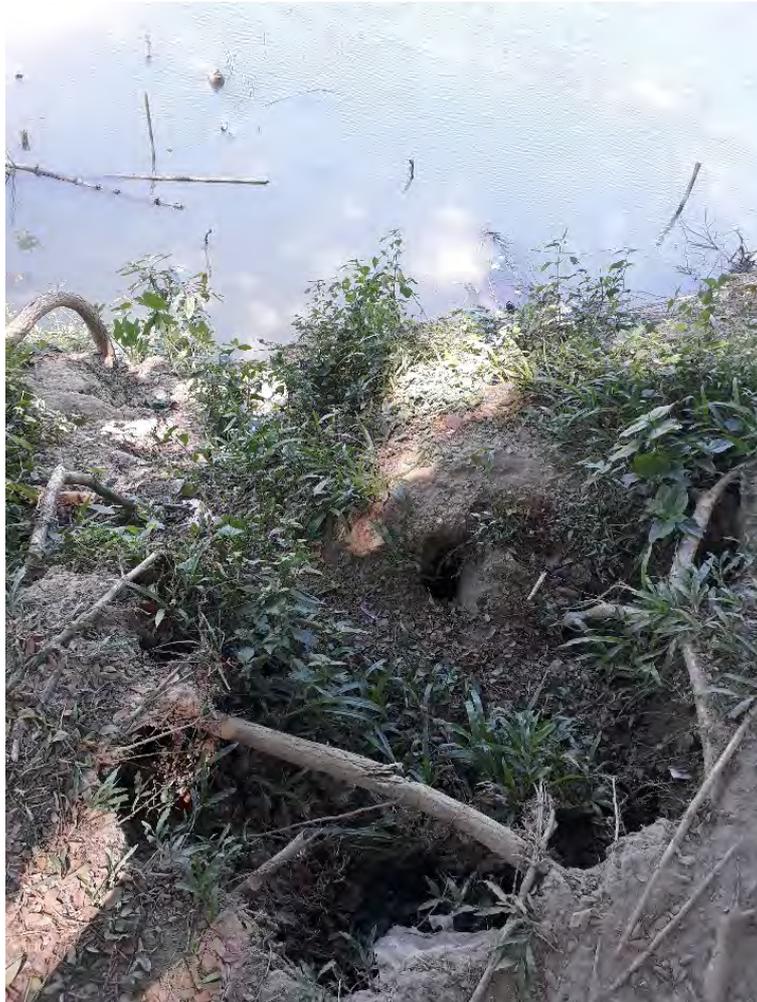
EMI Cambodia noticed significant surface scouring, as seen in Photo 3, near the Coffee Shop building. The director mentioned these holes were new since they've built the concrete road through the property in the last two years. Some scour holes were as big as 5 feet by 2 feet and 1-2 feet deep.

Photo 3 Scouring from surface water runoff on top of the riverbank

The scope of work and the attached drawings are a plan to mitigate further erosion. This revetment design will not solve any on-site flooding or scouring. In order to solve any flooding on the property, additional drainage and some grading would be required to direct the water away from buildings and into a channel in order to prevent sheet flow from occurring (which causes the scouring and further erosion).

EMI Cambodia would recommend starting with building a drainage ditch along the edge of the new concrete road and extending the output of the drainage pipes from the Coffee Shop sinks so that the end of the pipe overhangs well into the river. The output of the drainage pipe is currently directly outside of the Coffee Shop with evidence of erosion.

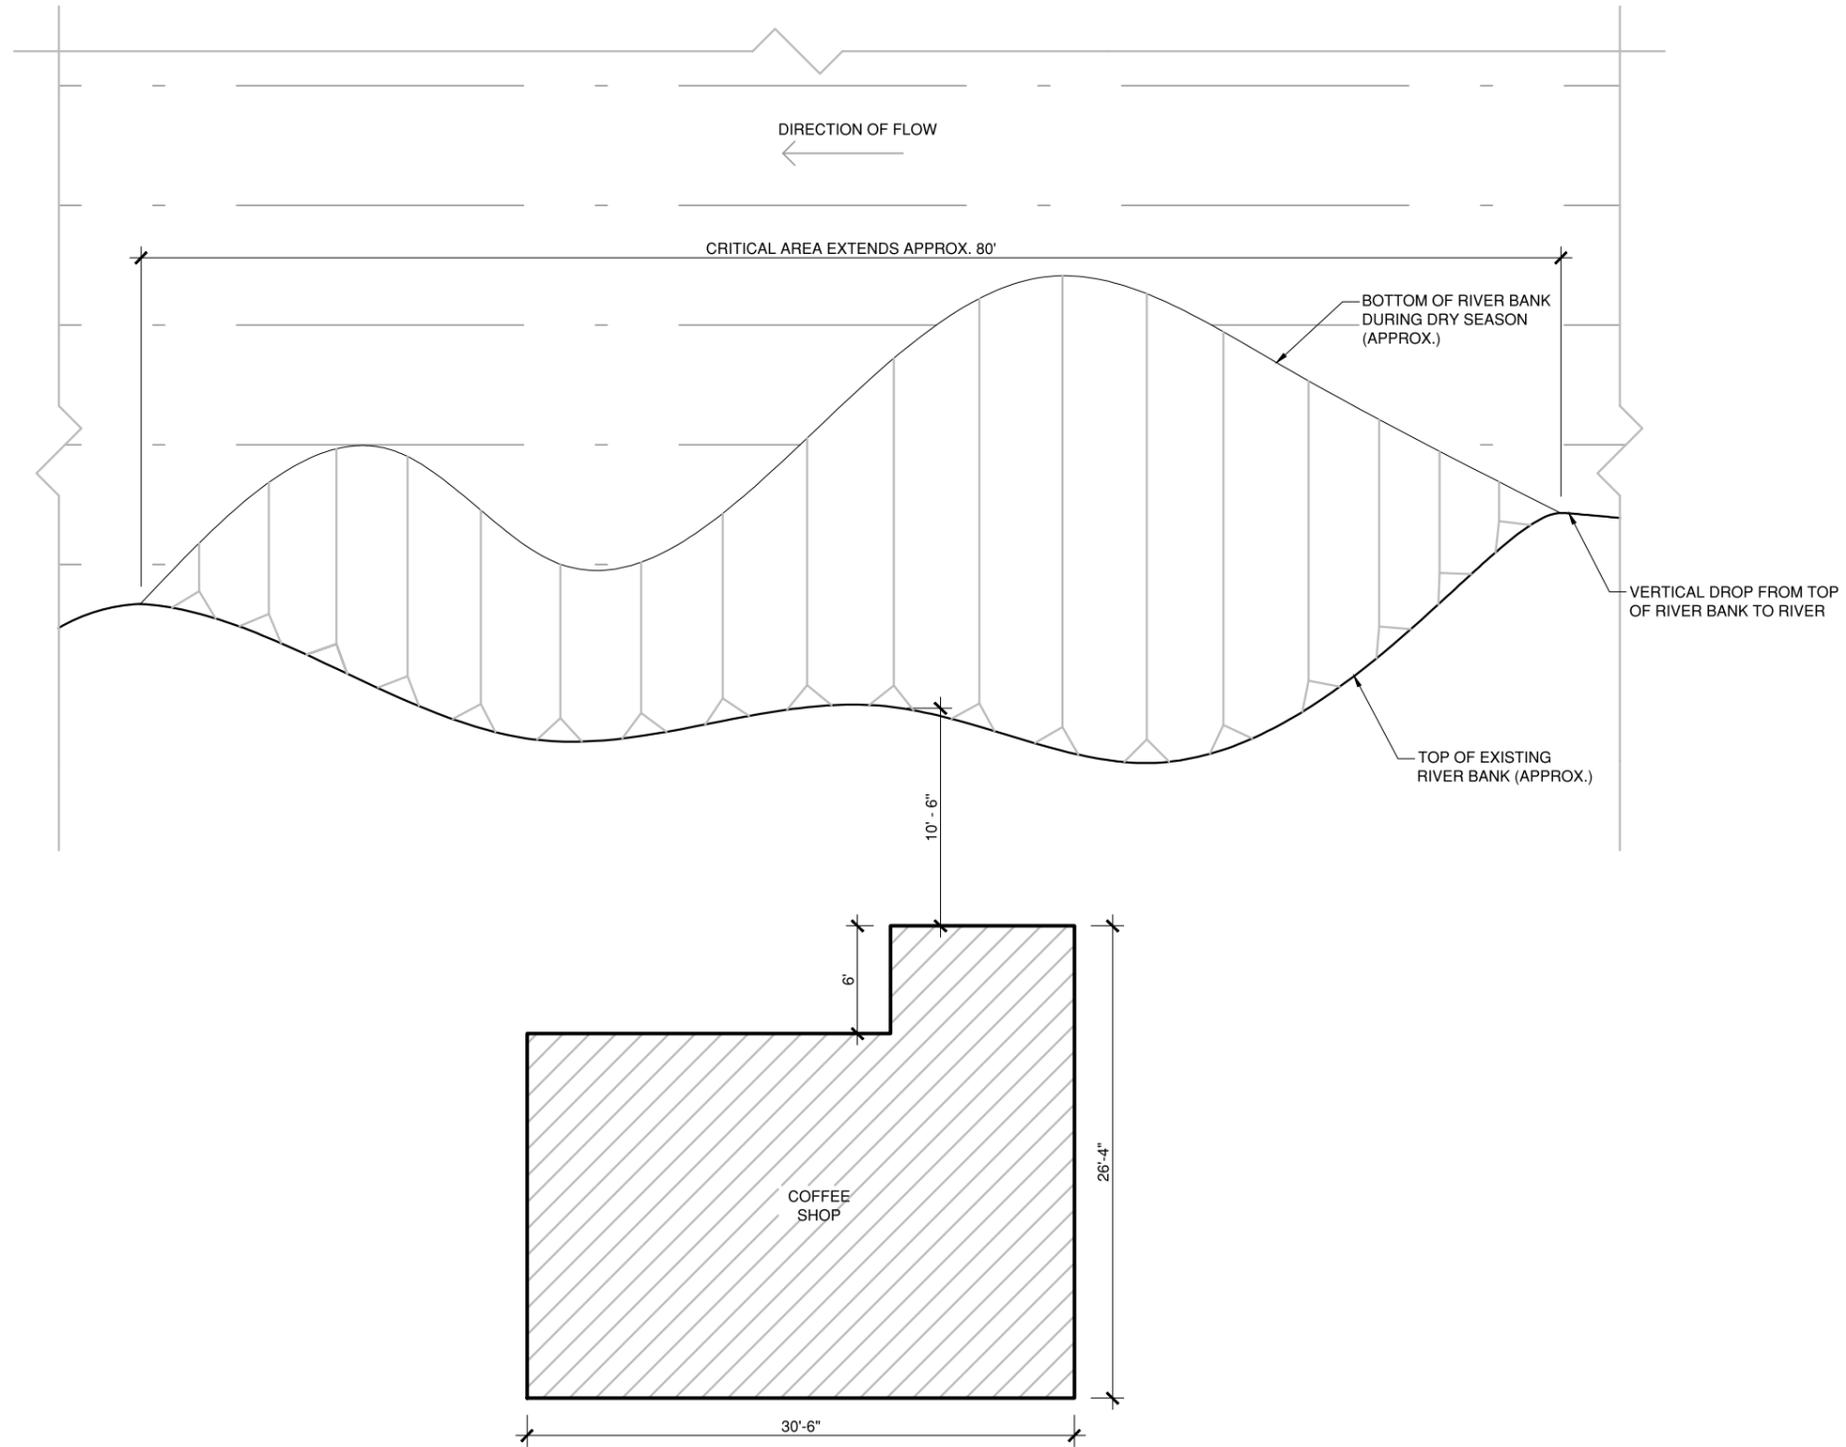
1 EXISTING RIVER BANK IN CRITICAL AREA - PLAN VIEW
1"=10'

1. A SURVEY OF THE SITE WAS NOT PERFORMED FOR THE PURPOSE OF THIS DESIGN.
2. THE BOUNDARY OF THE RIVER BANK AND GROUND ARE DRAWN BASED ON VISUAL FIELD OBSERVATIONS.
3. DIMENSIONS PROVIDED WERE DETERMINED USING A TAPE MEASURE.
4. THE CRITICAL AREA IS APPROXIMATELY 80' OF THE RIVER BANK IN FRONT OF THE COFFEE SHOP. THE ERODED RIVER BANK IN THIS AREA IS 10' 6" FROM UNDERTAKING THE COFFEE SHOP. THE RUNOFF FROM THE COFFEE SHOP AND THE CONCRETE ROAD NEARBY IS ALSO CONTRIBUTING TO THE EROSION IN THIS AREA.
5. THE RIVER BANK ON BOTH SIDES OF THIS CRITICAL AREA ALSO HAS SIGNIFICANT EROSION; HOWEVER, NO BUILDINGS ARE AT RISK.
6. IN THIS CRITICAL AREA, DURING DRY SEASON, THE LOWER GROUND SURFACE IS VISIBLE. HOWEVER, IN OTHER AREAS ALONG THE RIVER, THE TOP OF THE RIVER BANK DROPS VERTICALLY TO THE RIVER.

1. THE EXISTING TOP OF THE RIVERBANK SHOULD BE CUT BACK APPROXIMATELY 5' TO 15' (DEPENDING ON THE AREA) IN ORDER TO CREATE A SLOPED AND BENCHED RIVER BANK DOWN TO THE RIVER.
2. THE FLAT BENCH IS IMPORTANT TO STABILIZE THE SLOPE AND TO REDUCE THE VELOCITY OF ANY WATER FLOWING INTO THE RIVER.
3. TO HELP STABILIZE THE PROPOSED SLOPED AND BENCHED RIVERBANK, BAKAU PILES AND A CHAINLINK FENCE SHOULD BE INSTALLED AT THE TOE.
4. THE CHAINLINK FENCE SHOULD BE INSTALLED ON RIVERBANK SIDE OF THE POSTS AS SEEN IN C3 AND C4.
