Pre-disaster Risk Assessment

Earthquake Risk Assessment of Compassion International Partner Facilities

Located in Northeast Haiti

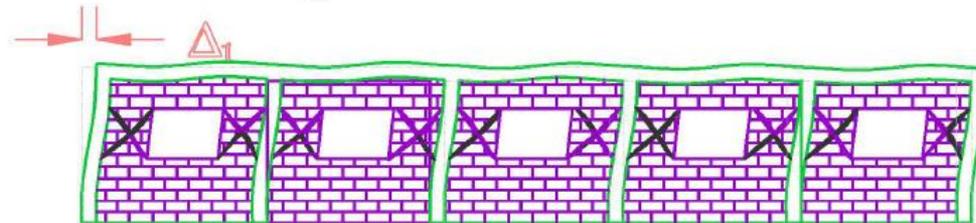
FIGURE 5 - SOUTH ELEVATION

FIGURE 6 - UNCONFINED WALLS

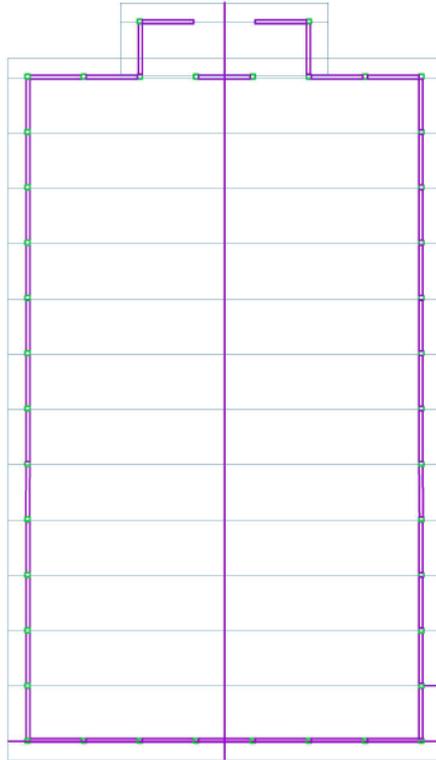
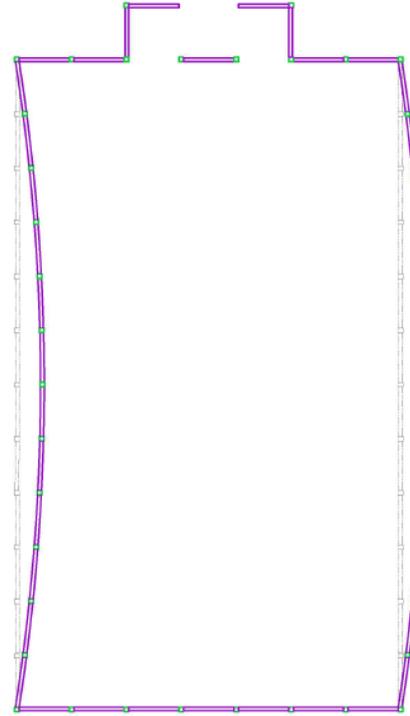
Lack of Roof Diaphragm

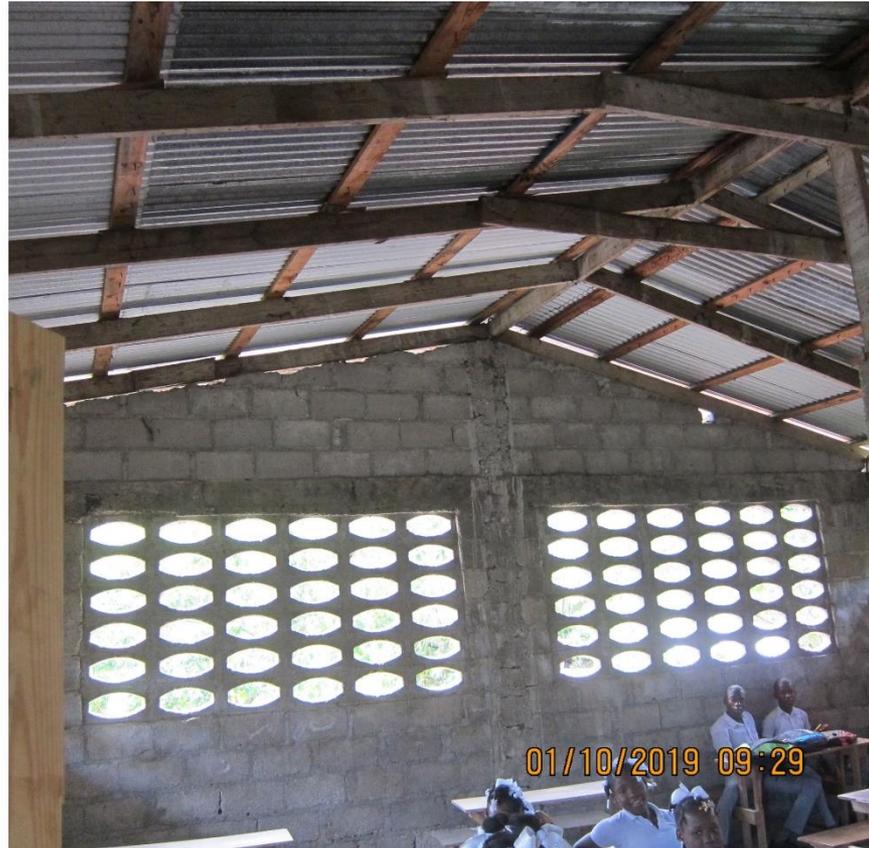
Gable Ends

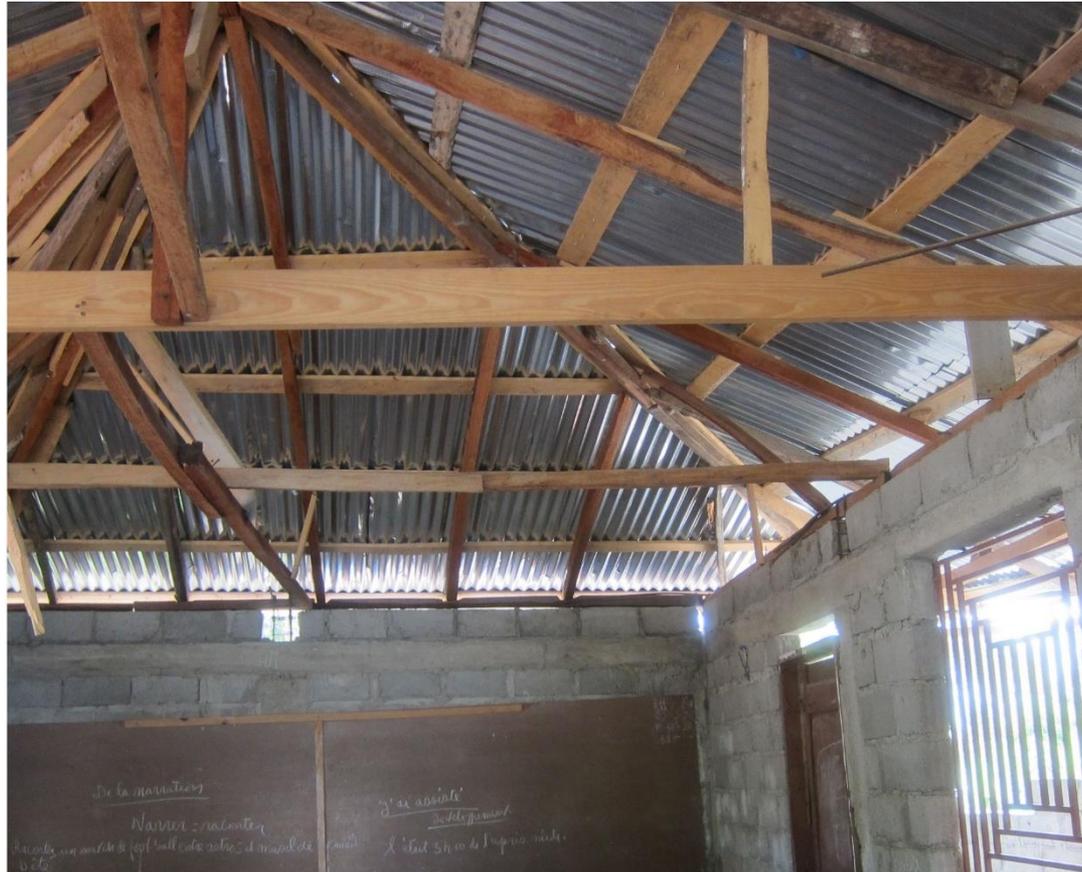
Poor Roof-to-Wall Connections

Add Cross Walls & Ties

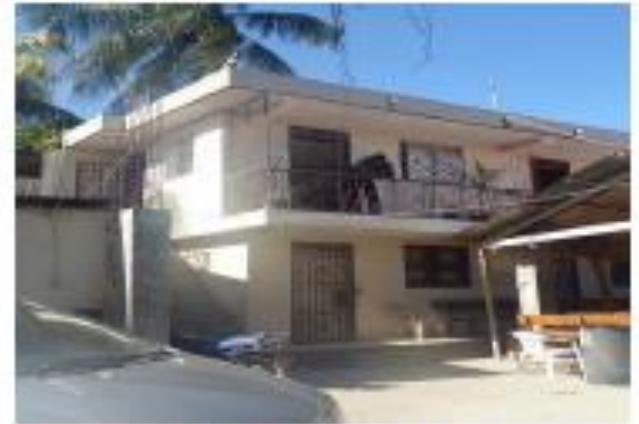
Building HA0744-A

Day Evaluated:	January 7, 2019
Function:	Project Office/ Survivor
No. of Stories:	2
Risk Rating:	Moderately Low
Damage Observations:	None
Vulnerabilities:	Not adequate lateral walls to resist loads.
Recommendations:	Add masonry to main floor interior 760 mm wide by full height opening.
