Getting Design and Construction on the Appropriate Track: A Structural Case Study

This course is a case study of EMI Uganda's partnership with Congo Initiative (CI) through the development of their university campus, UCBC.

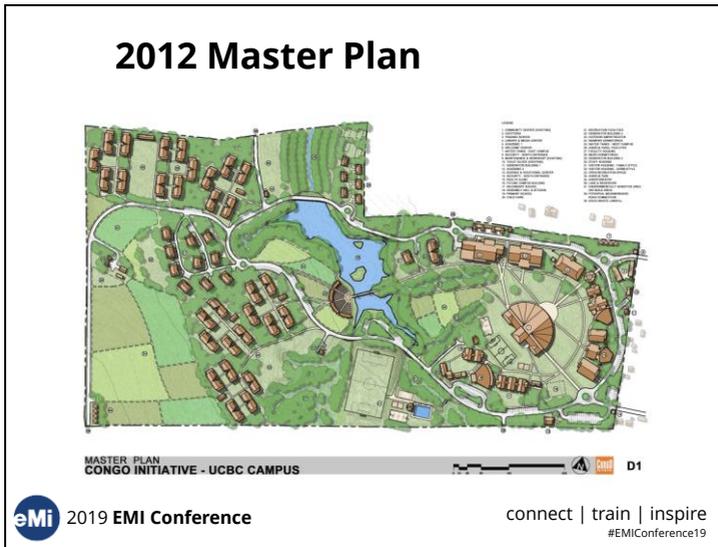
Here is the original master plan. The site is 85 acres. The full build out capacity of the campus is 3000 students. There is a creek running through a ravine in the middle of the campus, with academic buildings on the east and residential buildings on the west. The centerpiece of the campus is the community center, located at the heart of the academic buildings.

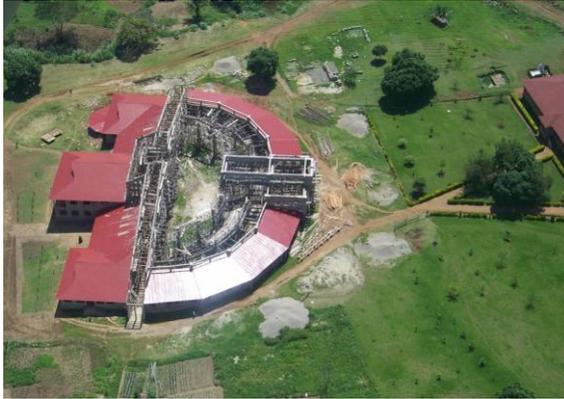
Here is the community center at the time of the original master plan. The building was partly constructed, though construction was put on hold due to lack of fund. Many spaces in the building were being used, though unfinished. We will talk more about this building.

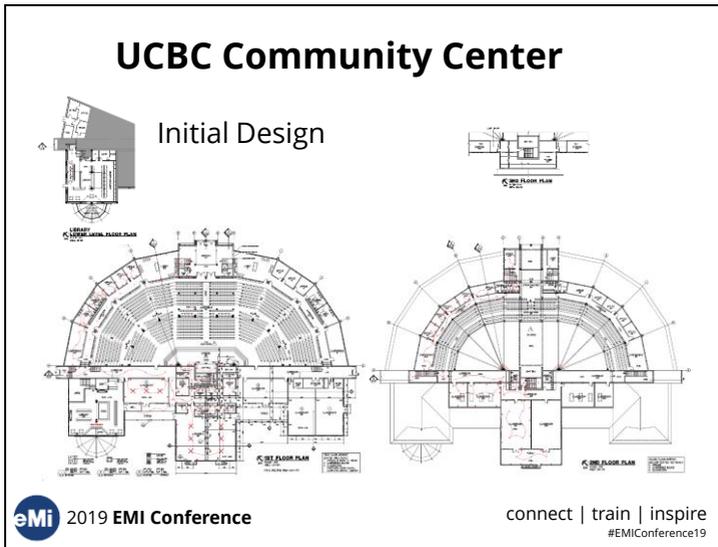
Here is the original plans. There is a partial walk out basement, two main levels and a small upper level. The building dimensions are approximately 300' long and 200' deep. The capacity of the auditorium is 2000 seat on the main level and 700 on the balcony.

Some of the issues with the design are poor natural ventilation and lighting, especially in the auditorium and the interior spaces. This would necessitate mechanical ventilation to make some of the spaces comfortable. While this is common practice in the states, it is not in Congo where electricity supply is inconsistent. Another challenge with the auditorium is the poor sightlines in many areas due to the balcony columns.

The drawings had insufficient detail to build from, lack of dimensions and construction details.

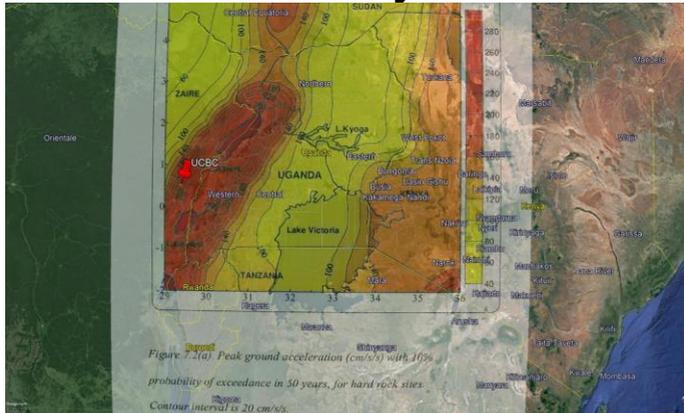
The structural design did not seem to account for seismic. Here is a peak ground acceleration map for the area, Beni has 25%g Peak ground acceleration 10% probability of exceedance in 50 years, 1 in 475yr return period. The highest recorded earthquake in the area is a 7.0 magnitude.

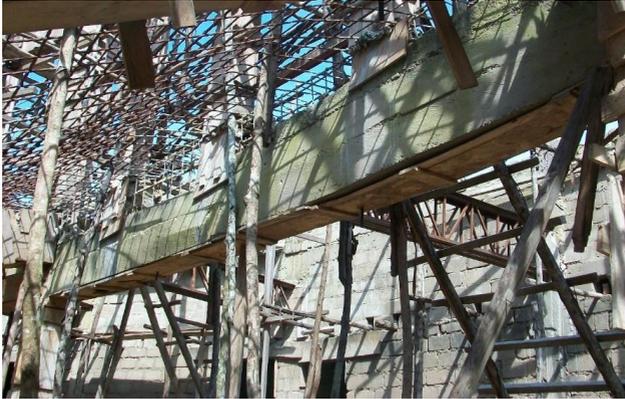
Here we see the challenge of building a larger scale than what is typical for local construction methods.

There balcony beams are 3' deep beams but the formwork wasn't braced enough and the face of the beams aren't flat. The construction team learned and this problem improved on further beams.

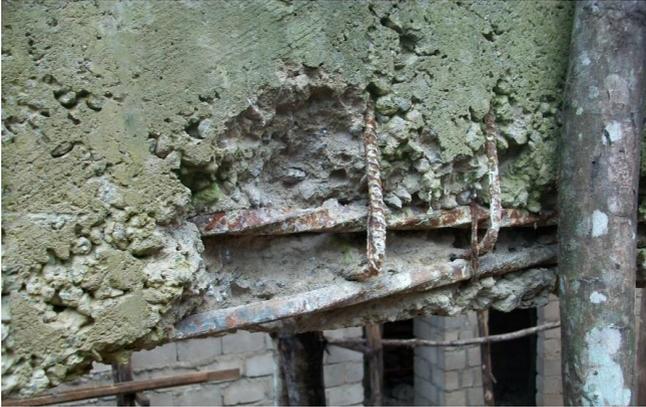
The longitudinal bars splice is not within stirrup cage.

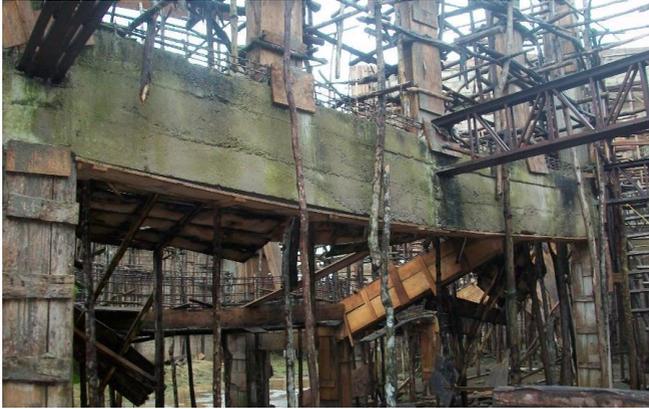
Notice beam sag

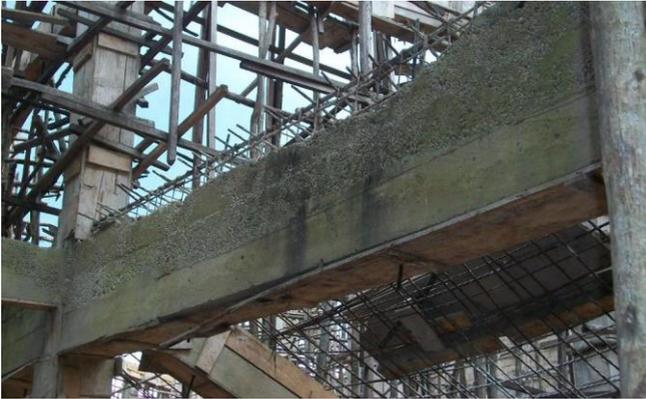
Concrete beam has been poured in layers, it is poorly bonded and the top is poorly consolidated.

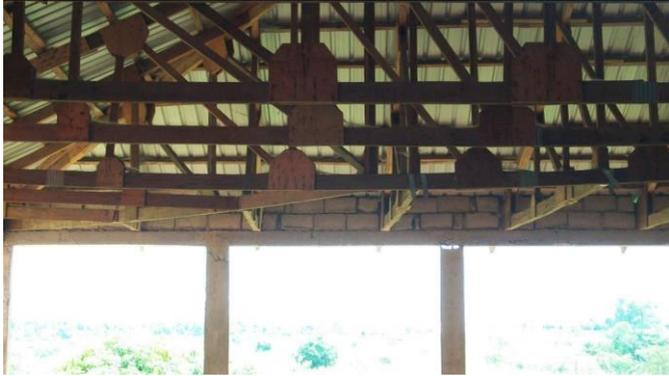
Notice architectural feature of a window at top of column.
What is harder to notice in this picture is the sag in girder truss. And ceiling not yet installed

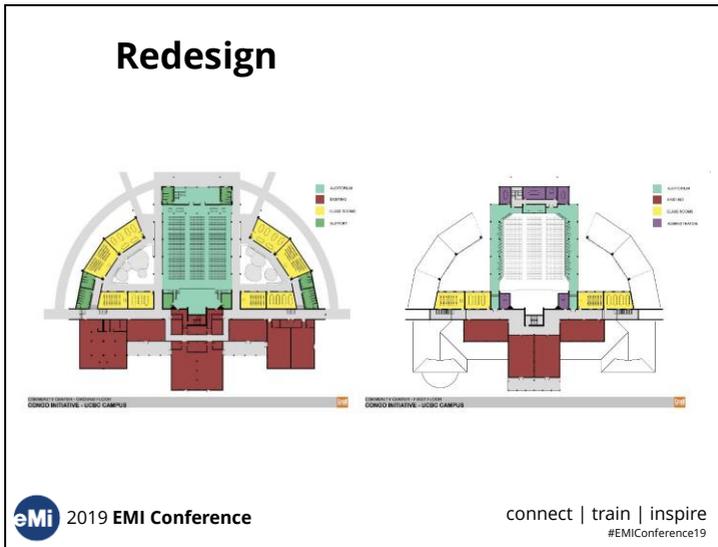
Here are the redesigned floor plans. The auditorium capacity was reduced from 2700 to 1000 people. It was separate from the wings to create more ventilation and natural lighting. The wings were changed from offices to classrooms. Eight new classrooms were added adjacent to the auditorium. The first floor has a significantly smaller balcony allowing a clear span across the main space. The upper floor has been removed.

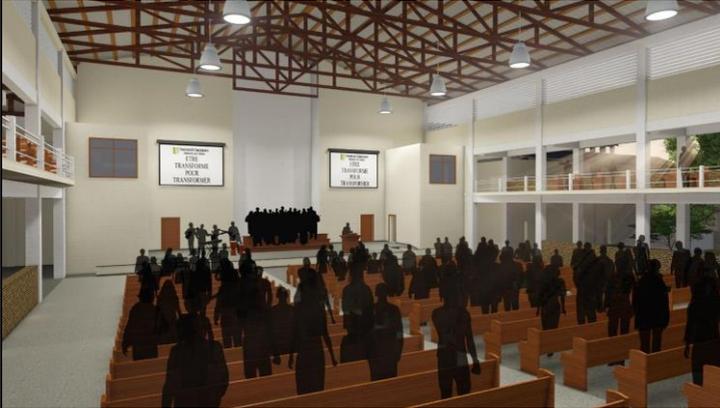
We can see the openness of the space and the natural light coming in from the sides. Also note the louvers at the top of the space creating more ventilation.

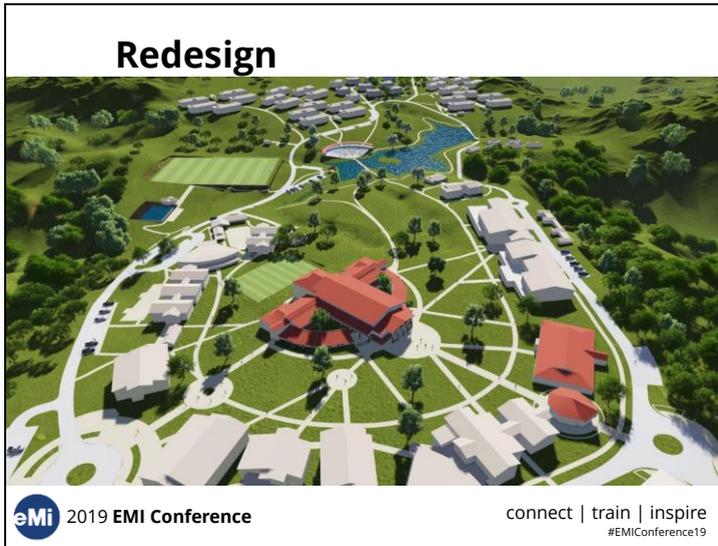
Here is an exterior render of the redesigned space.

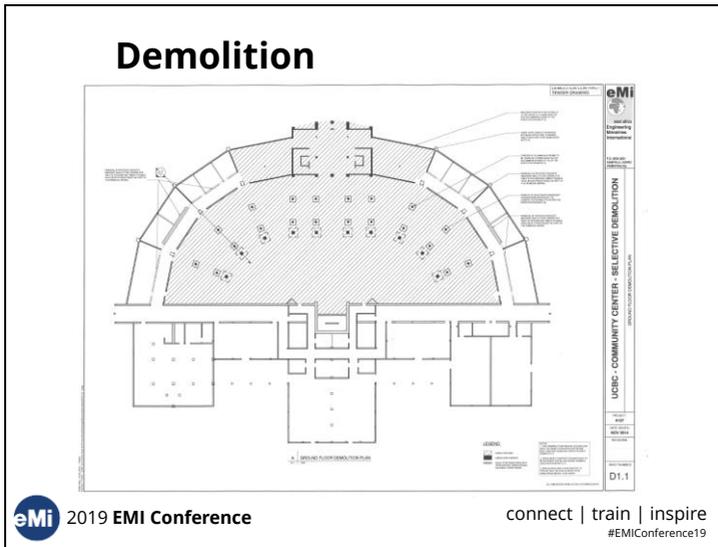
We start with demolition of the auditorium space. The hatched area is what was demolished, all the balcony structure and the main entrance.

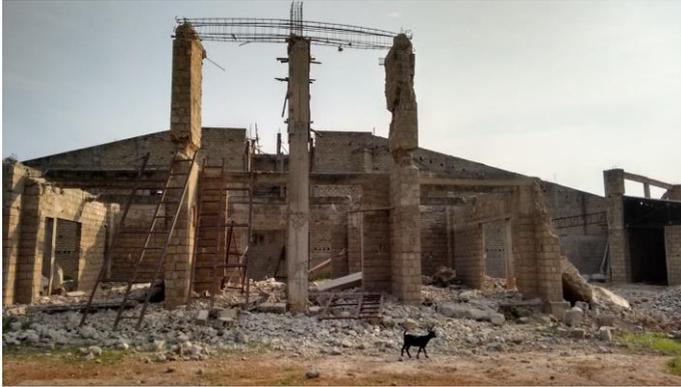
Demolition

Here we see the removal of the balcony.

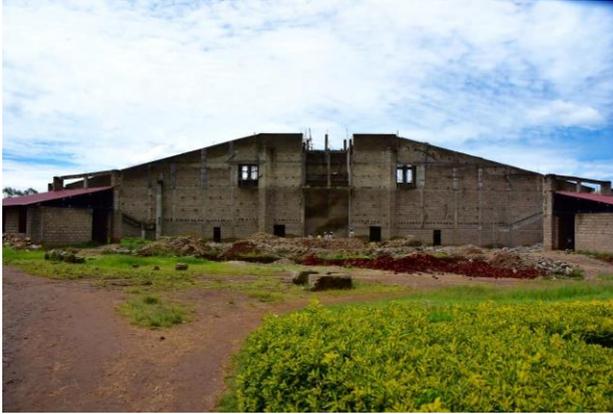
Demolition

Here we see progress on demolition of the front entrance

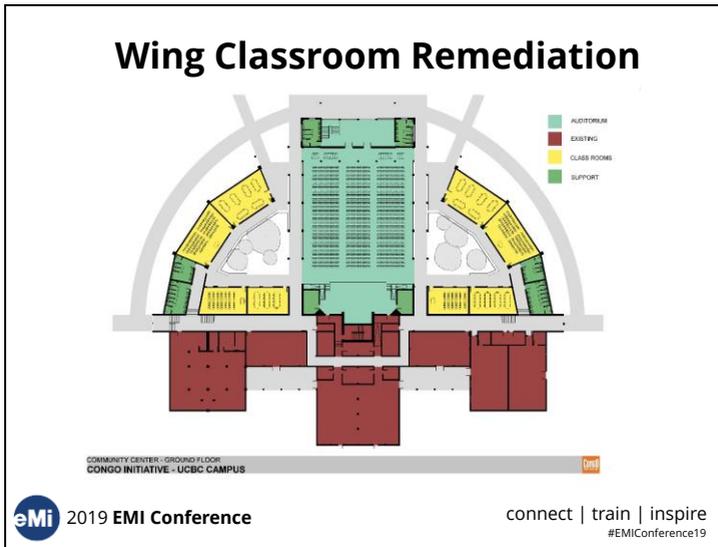
The first stage of construction was remediation of the wing adjacent to the auditorium, seen here in yellow. We began here as this was the only single storey section of the building and it required the least work. It gave opportunity to evaluate the contractor and understand the constraints of the building in Beni.

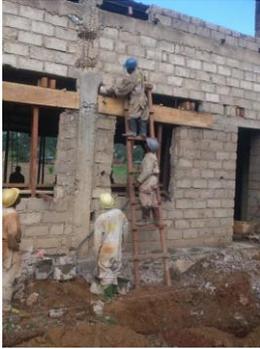
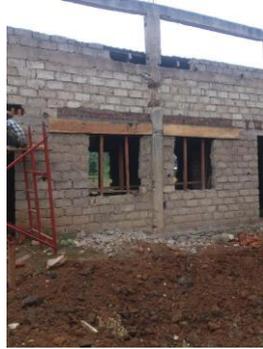
Column and Beam Repairs

Here is some of the repairs

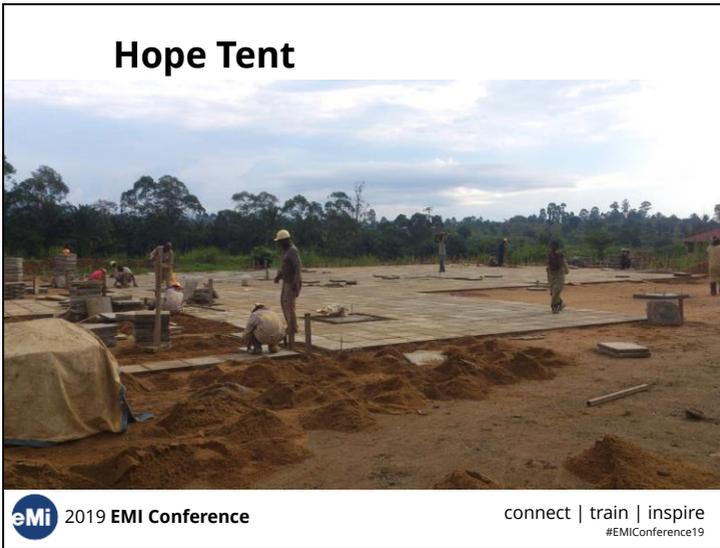
Here we see the site preparations, compaction, laying paving stones, and foundations for the tent.

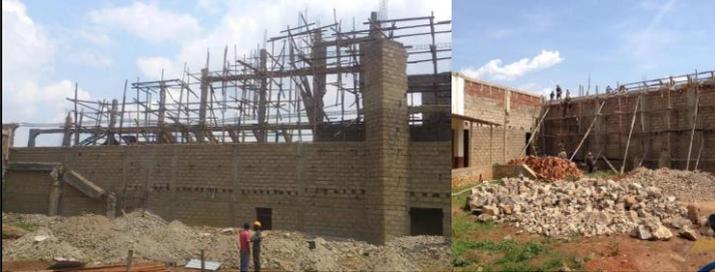
Once the tent was erected, demolition could begin on the corridor. The height of the original corridor was 47' with minimal connection between the two walls. We had concerns over the stability of the walls and poor quality masonry units.

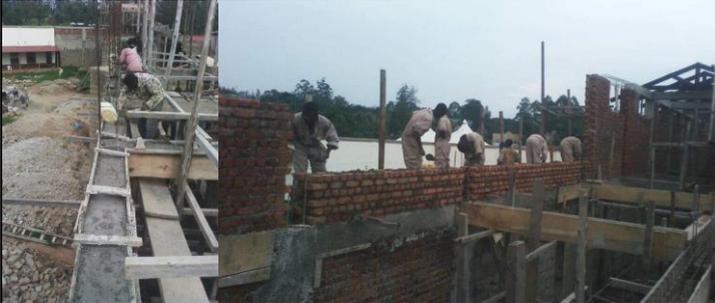
The walls we demolished down and new ring beam and connecting beams poured. Then the walls were built back up to roof level and room installed.

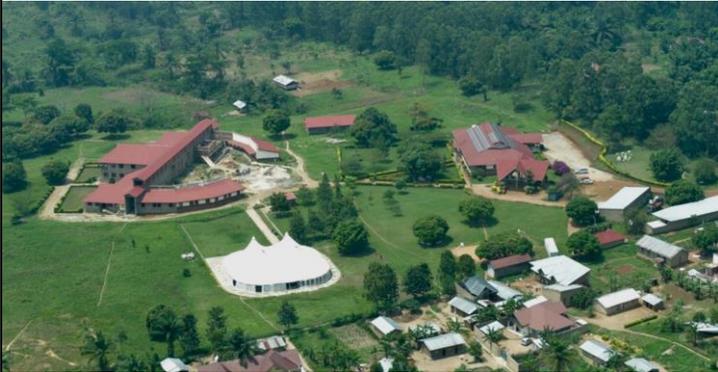
We can see the finished corridor. This was an exciting accomplishment for the university as it was the first time that a roof was over the entire building.

We can see in this corner then next phase of construction, a 2 storey new addition with 4 classrooms.

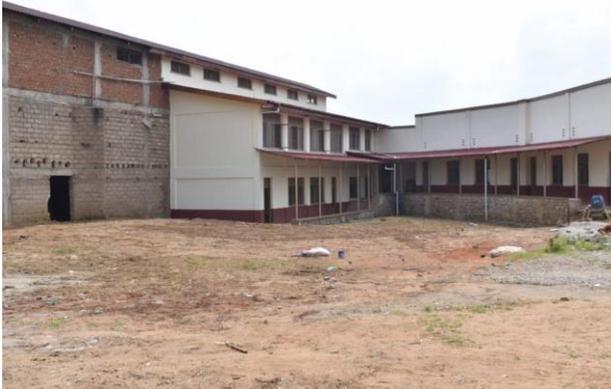
And here is the finished spaces. You can notice the staging of the corridor wall. This area is left unfinished until the auditorium construction.

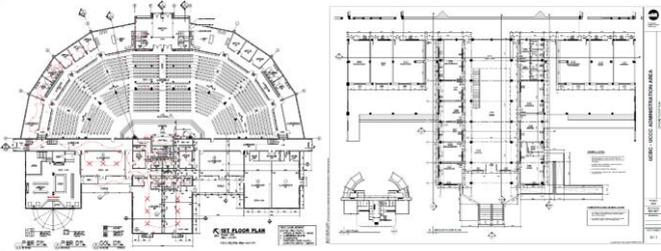
Just as the construction was being phased, the design was being phased as EMI was able and to stay ahead of construction. As we began looking into the back of the building, we re-evaluated the needs of UCBC and CI at the time. The most pressing need was for office space. There was a desire to have the core of the organization in the community center building as it is the focal point of the campus.

As we considered the space, this is 60' across. We introduced a atrium and clerestory to allow natural light and ventilation into the space. Offices in the center of the space would not be very comfortable.

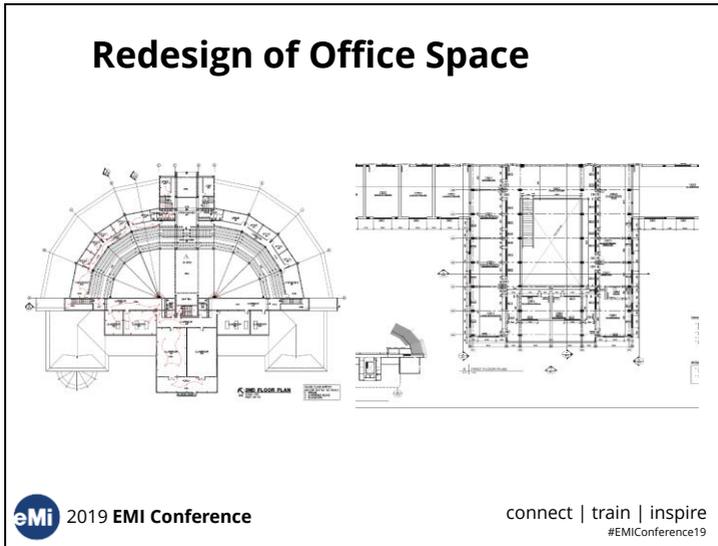
Here is the second floor plan. Since the money was yet to be raised, we designed flexibility into the wall locations so when construction begins we can adjust based on the current needs.

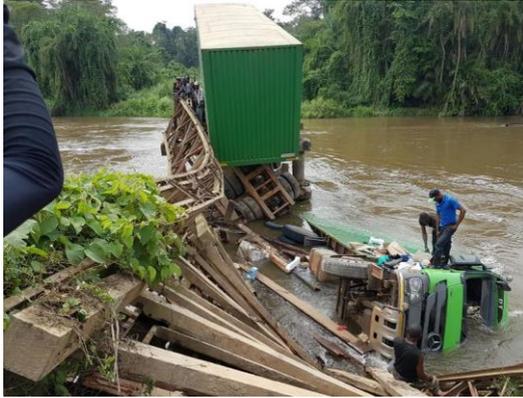
I will end with the challenge of transportation. Here is the bridge crossing the Semliki River, the main transportation route into Beni from Uganda. It was repaired but in the meantime trucks would meet on either side of the river and small boats would transport the materials across to the other truck.
