GARDEN HOME

Erosion Mitigation Plan

Report

Project Number: KH-1025

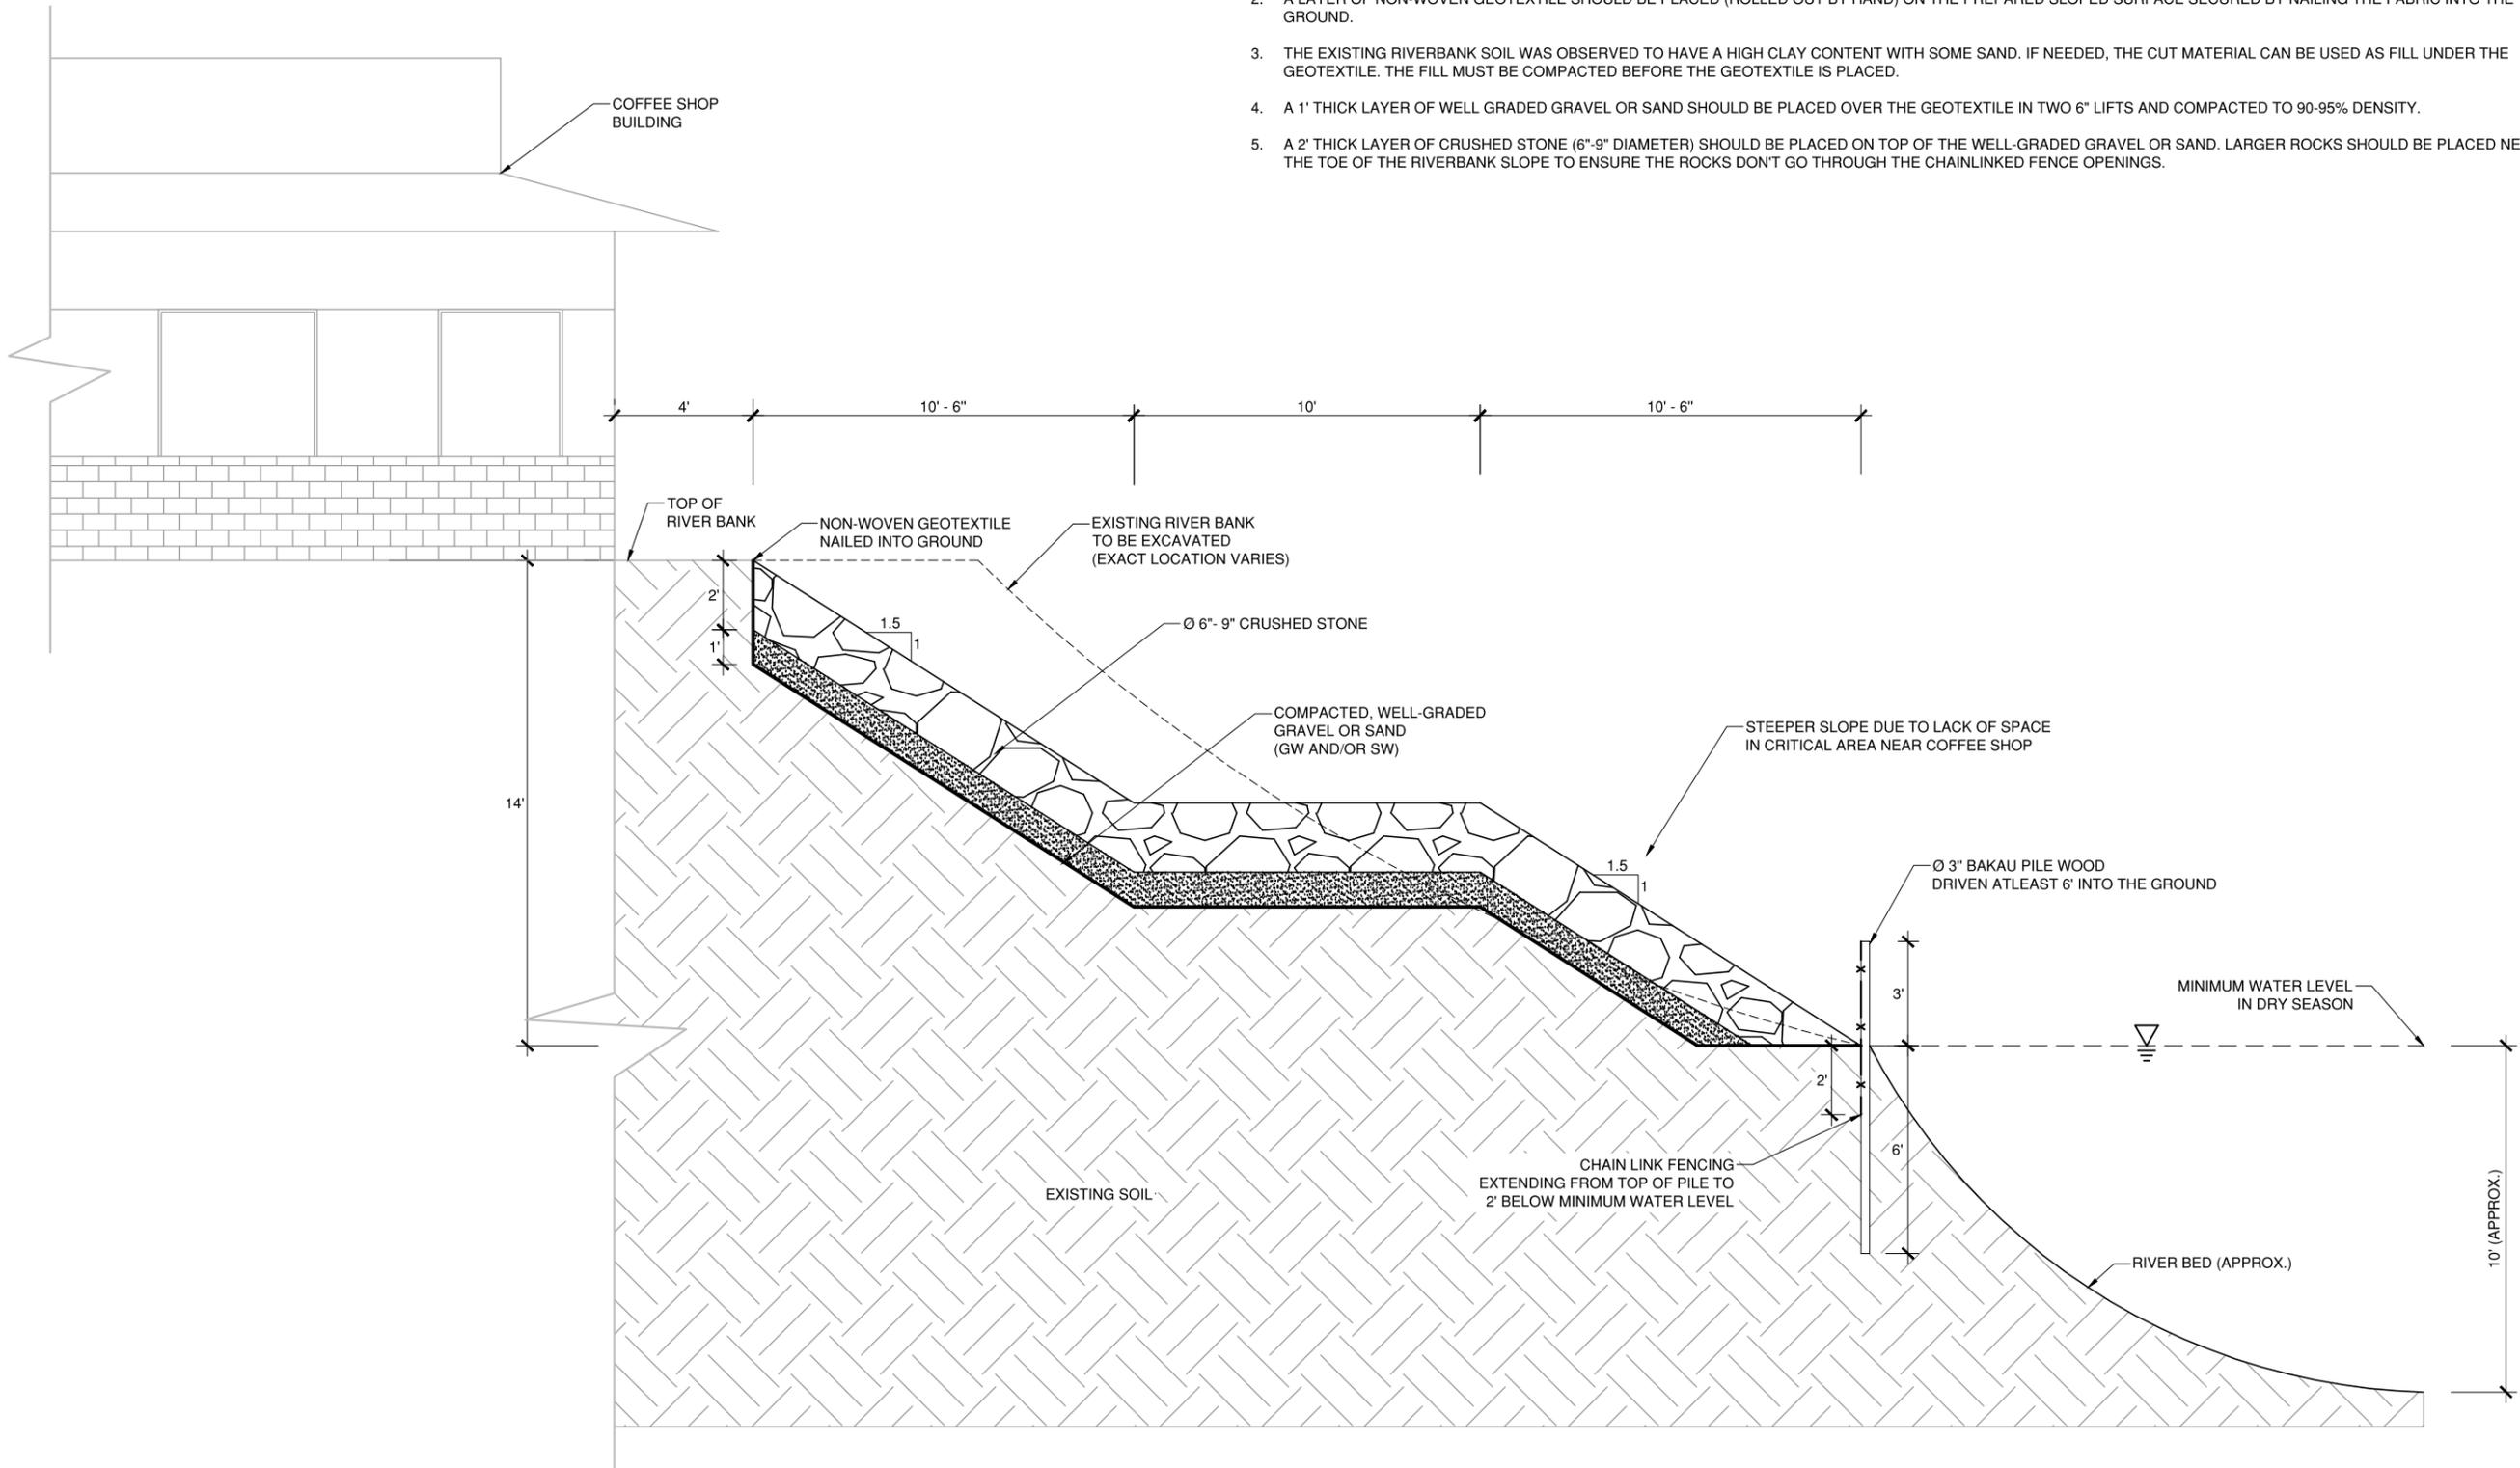
1 PROPOSED RIVER BANK SECTION VIEW IN CRITICAL AREA ONLY (IN FRONT OF COFFEE SHOP)
1" = 5'

1. THE RIVERBANK SHOULD BE EXCAVATED AND SLOPED AS SHOWN IN THIS DRAWING.
2. A LAYER OF NON-WOVEN GEOTEXTILE SHOULD BE PLACED (ROLLED OUT BY HAND) ON THE PREPARED SLOPED SURFACE SECURED BY NAILING THE FABRIC INTO THE GROUND.
3. THE EXISTING RIVERBANK SOIL WAS OBSERVED TO HAVE A HIGH CLAY CONTENT WITH SOME SAND. IF NEEDED, THE CUT MATERIAL CAN BE USED AS FILL UNDER THE GEOTEXTILE. THE FILL MUST BE COMPACTED BEFORE THE GEOTEXTILE IS PLACED.
4. A 1' THICK LAYER OF WELL GRADED GRAVEL OR SAND SHOULD BE PLACED OVER THE GEOTEXTILE IN TWO 6" LIFTS AND COMPACTED TO 90-95% DENSITY.
5. A 2' THICK LAYER OF CRUSHED STONE (6"-9" DIAMETER) SHOULD BE PLACED ON TOP OF THE WELL-GRADED GRAVEL OR SAND. LARGER ROCKS SHOULD BE PLACED NEAR THE TOE OF THE RIVERBANK SLOPE TO ENSURE THE ROCKS DON'T GO THROUGH THE CHAINLINKED FENCE OPENINGS.
